Rail Accident Investigation Branch

# Rail Accident Report

## Freight train derailment at Eastleigh, Hampshire 28 January 2020

Report 02/2021  
March 2021

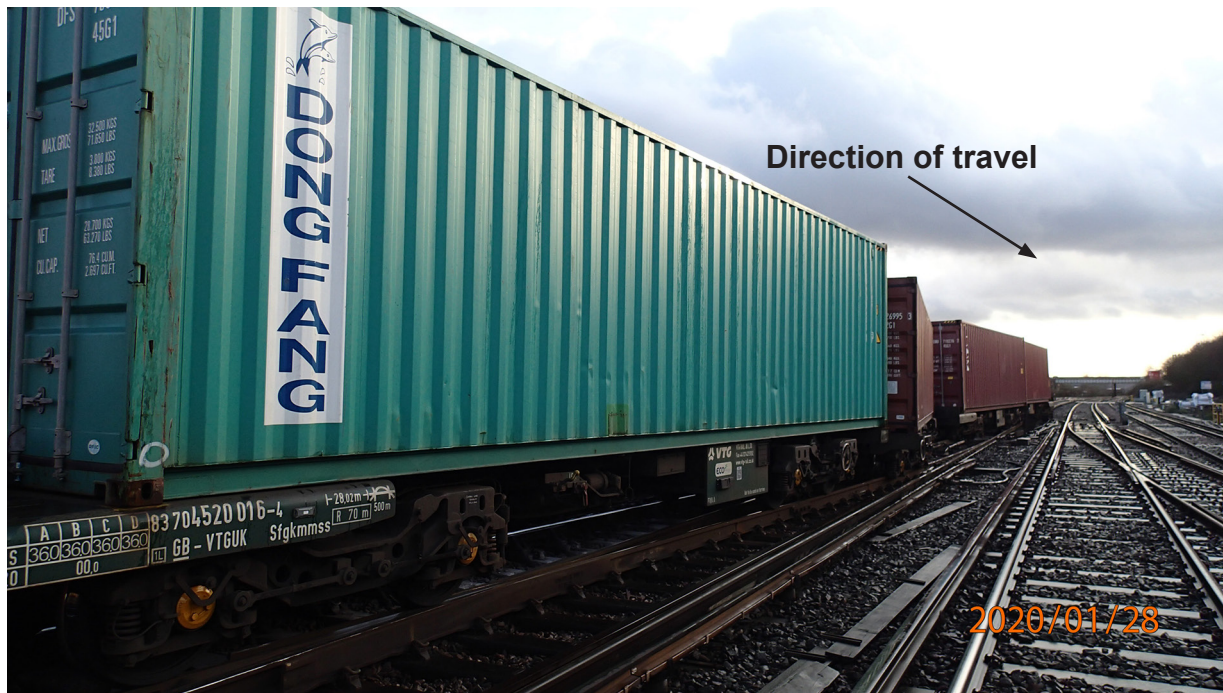
- 5 Significant damage was caused to the points at Eastleigh West Junction. The recovery of the train and infrastructure repairs caused the line to be closed for five days, and resulted in disruption to services for several weeks. The train suffered minor damage. Nobody was injured in the accident, although one member of infrastructure maintenance staff was almost struck by flying debris.

Figure 2: The derailed wagons following the accident

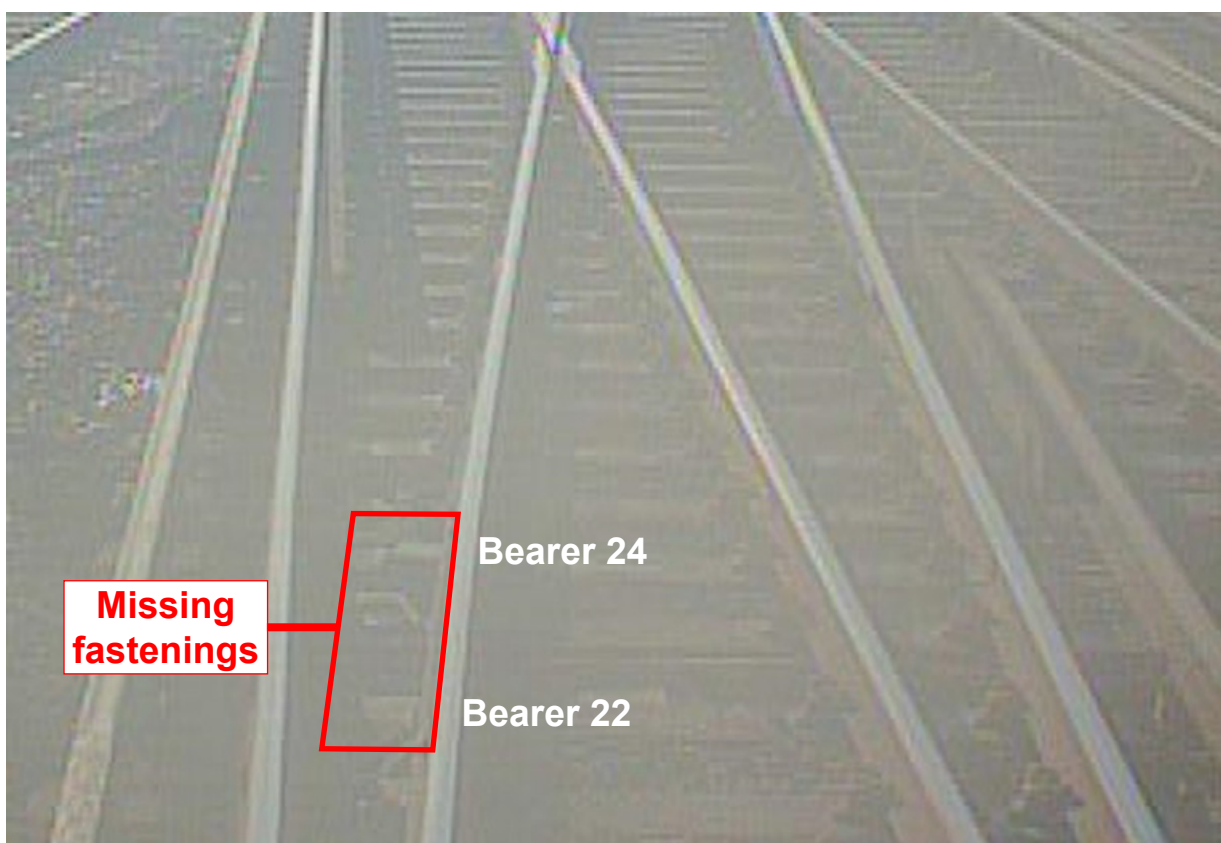
Figure 4: Forward facing CCTV from 2S27 showing three missing fastenings on bearers 22, 23 and 24 (image courtesy of South Western Railway)

- 42 Forward facing CCTV from train 2S27 confirmed that three of the nine fastenings found to have failed after the accident were missing prior to the passage of train 4O05 (paragraph 23). These were the fastenings to the left-hand side of the closure rail at bearers 22, 23 and 24 (figure 9).

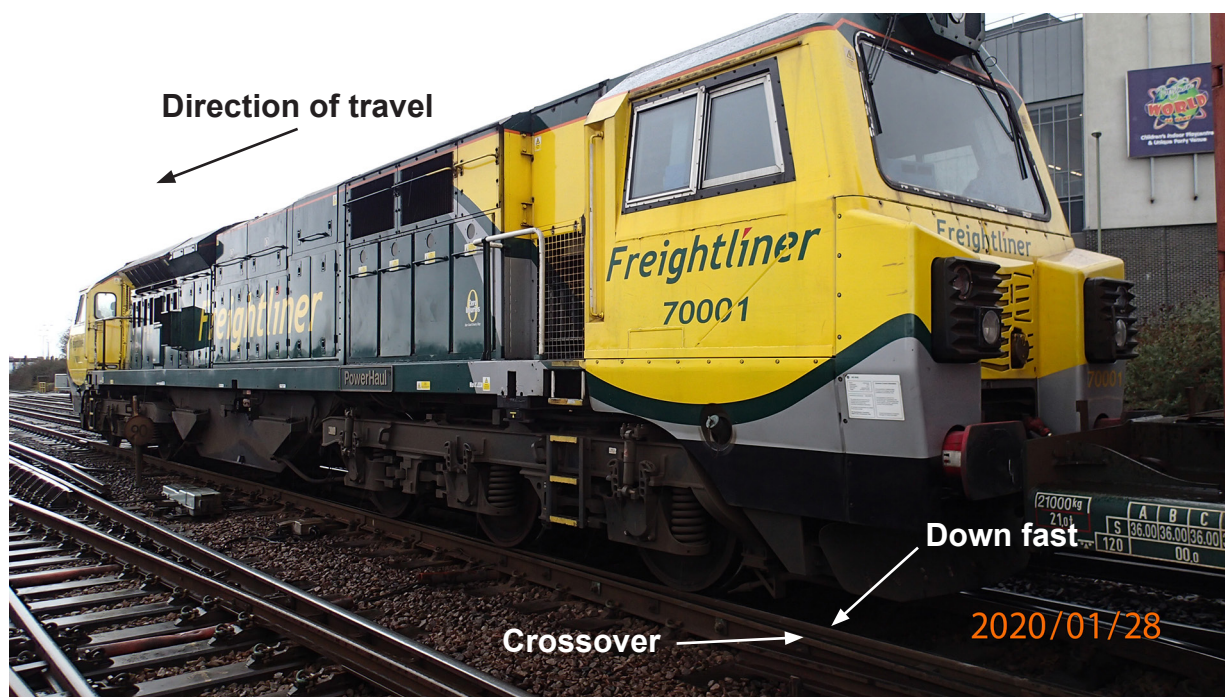
- 26 The locomotive continued to run derailed, causing damage to the track, before rereiling itself while traversing 450B points as it reached the down fast line (figure 6). The first three wagons and the fifth wagon of the train derailed on the section of track damaged by the locomotive. This caused further damage to the track.
- 27 The driver felt the train lurch as it passed over 450A points and made an emergency brake application. The train subsequently stopped with the locomotive around 90 metres beyond the point of derailment.

Figure 6: The locomotive following the derailment showing its final position with the rear bogie on the down fast

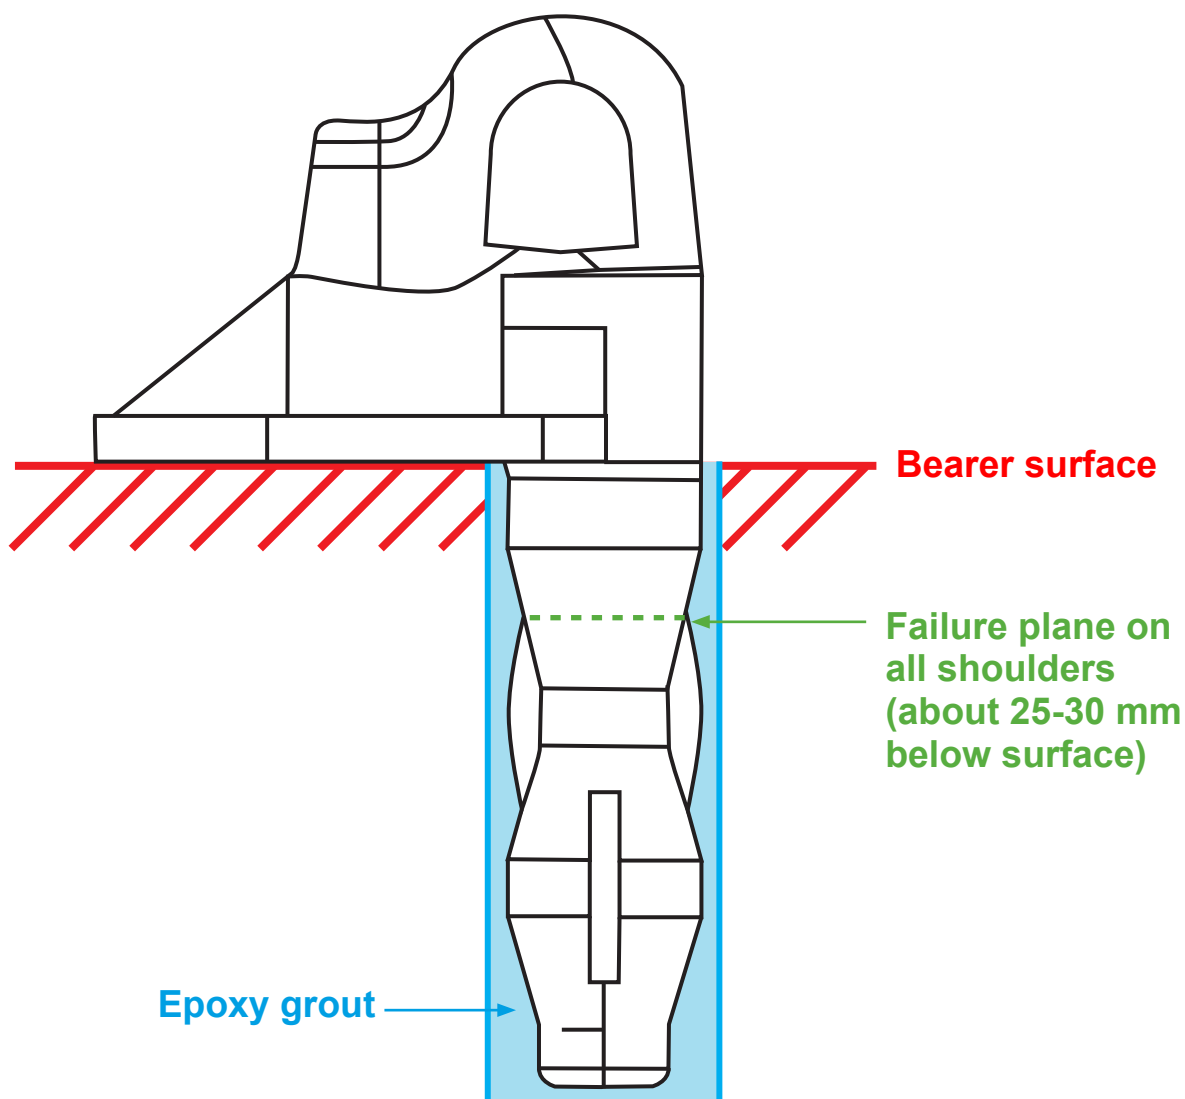
- 40 A site survey undertaken by RAIB and Network Rail following the derailment found that the left-hand closure rail of 450A points had moved laterally, widening the track gauge enough so that the locomotive's wheels were able to drop into the space between the rails and derail (paragraph 25). This survey found that a total of nine consecutive fastenings had failed along the left-hand closure rail. For comparison, module 3 of NR/L2/TRK/001 states that maintenance action must be taken where three or more consecutive fastenings are missing or ineffective.
- 41 An examination of the fastenings which failed showed that they had all done so via a fracture through the stem of their cast iron shoulders, at a point approximately 30 mm below the surface of the bearer (figures 7 and 8). This is one of the narrowest parts of the stem in the direction of the failure.

Figure 7: Profile view of a cast iron shoulder indicating the typical plane of failure in green.

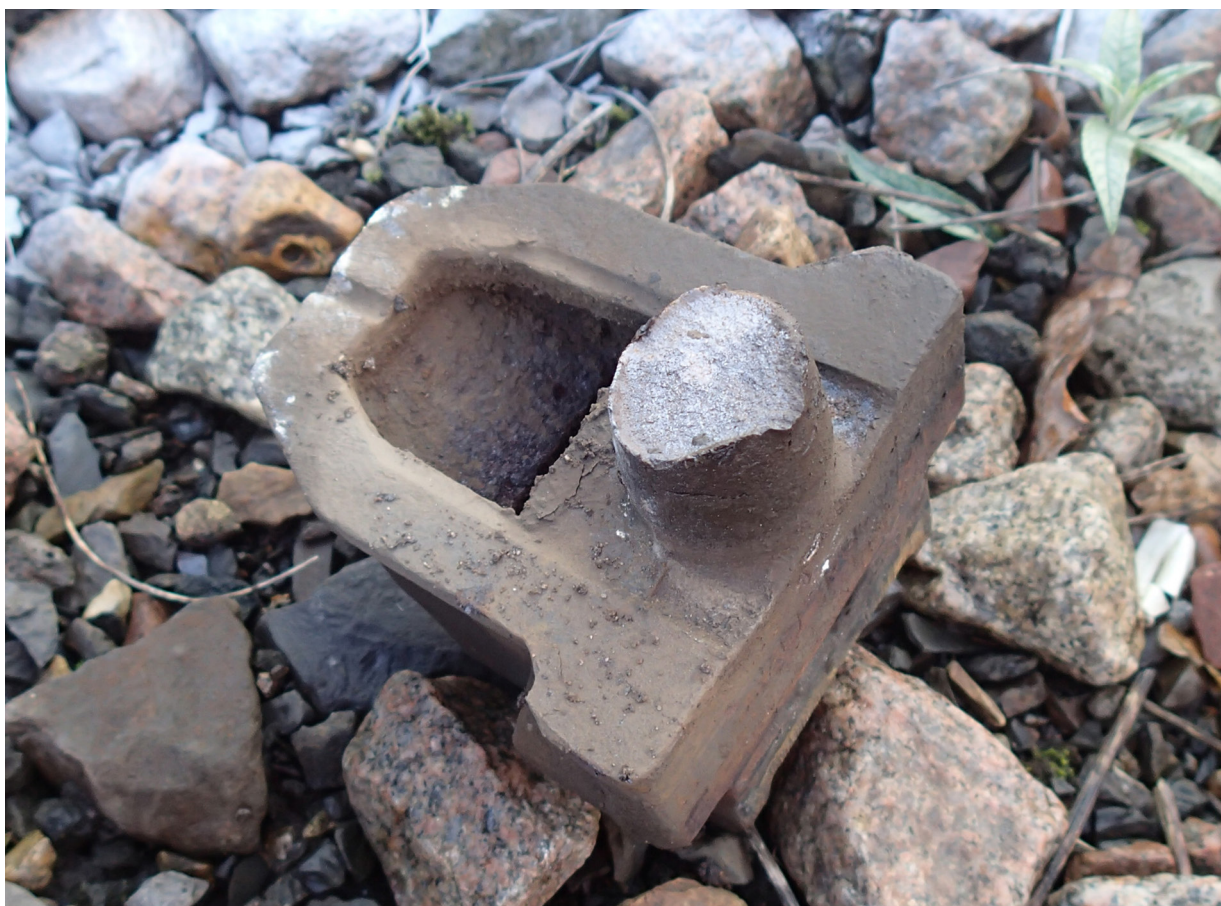
Figure 8: Photograph of one of the failed cast iron shoulders

- 44 An independent metallurgical inspection was commissioned by Network Rail on a sample of four of the fractured shoulders from 450A points, and the four found on the ground nearby. This inspection, combined with other analysis commissioned by Network Rail, showed that three of the shoulders from 450A points had failed in a fast-brittle manner (see paragraph 81), whereas the others had been subject to a fatigue failure (see paragraph 47). It is probable, given the failure mode of the surrounding shoulders, that the missing shoulder from bearer 22 was also subject to a fatigue failure (figure 9). This meant that six consecutive shoulders, from bearers 20 to 25 inclusive, were probably fractured along the left-hand closure rail prior to the derailment.

- 48 Metallurgical analysis showed that the shoulders from 450A points that had failed in fatigue had done so prior to the derailment. While this analysis was not able to quantify exactly how long a period these failures had existed for, corrosion on the fracture faces suggested that some had been in a failed condition for at least several months prior to the derailment, while others had failed more recently. The fracturing of these shoulders would have reduced the capacity of the track fastening system to maintain the required track gauge.
- 49 This causal factor arose due to a combination of the following:
- The design of the track fastening system made the cast iron shoulder stem more prone to fatigue failure under high lateral forces (paragraph 50).
  - Routine maintenance inspections were not capable of detecting and addressing broken shoulder stems (paragraph 58).

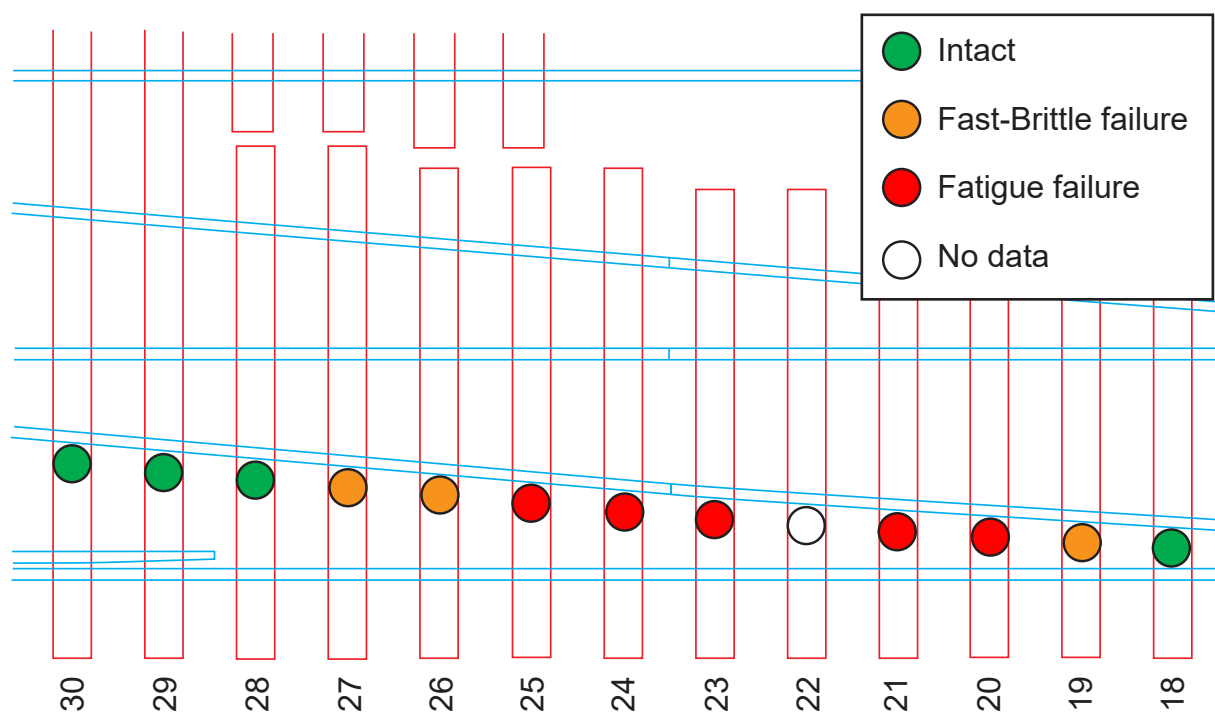
- 43 The missing shoulders from bearers 23 and 24 were recovered for further analysis, along with the six other fractured shoulders from 450A points. Four fractured shoulders which were found on the ground in the vicinity of the points were also recovered. The missing shoulder from the fastening on bearer 22 could not be positively identified due to the nature of the damage, but RAIB considers it was probably one of the four loose shoulders found near to the points, with the rest coming from other parts of the track that were damaged in the derailment.

Figure 9: Plan view of the area of derailment, highlighting the shoulders subject to a fatigue (red) or fast-brittle (orange) failure, or were intact (green). The shoulder on bearer 22 (white) could not be positively identified, but probably also failed in fatigue.

- 81 As well as pre-existing fatigue failures of some track shoulder stems, an examination of 450A points following the derailment showed that there had been fast-brittle failures in three of the shoulder stems (paragraph 44). A fast-brittle failure can occur in high strength, low ductility metals such as cast iron. It typically occurs when an item is subjected to a very high load and cracks suddenly and completely.

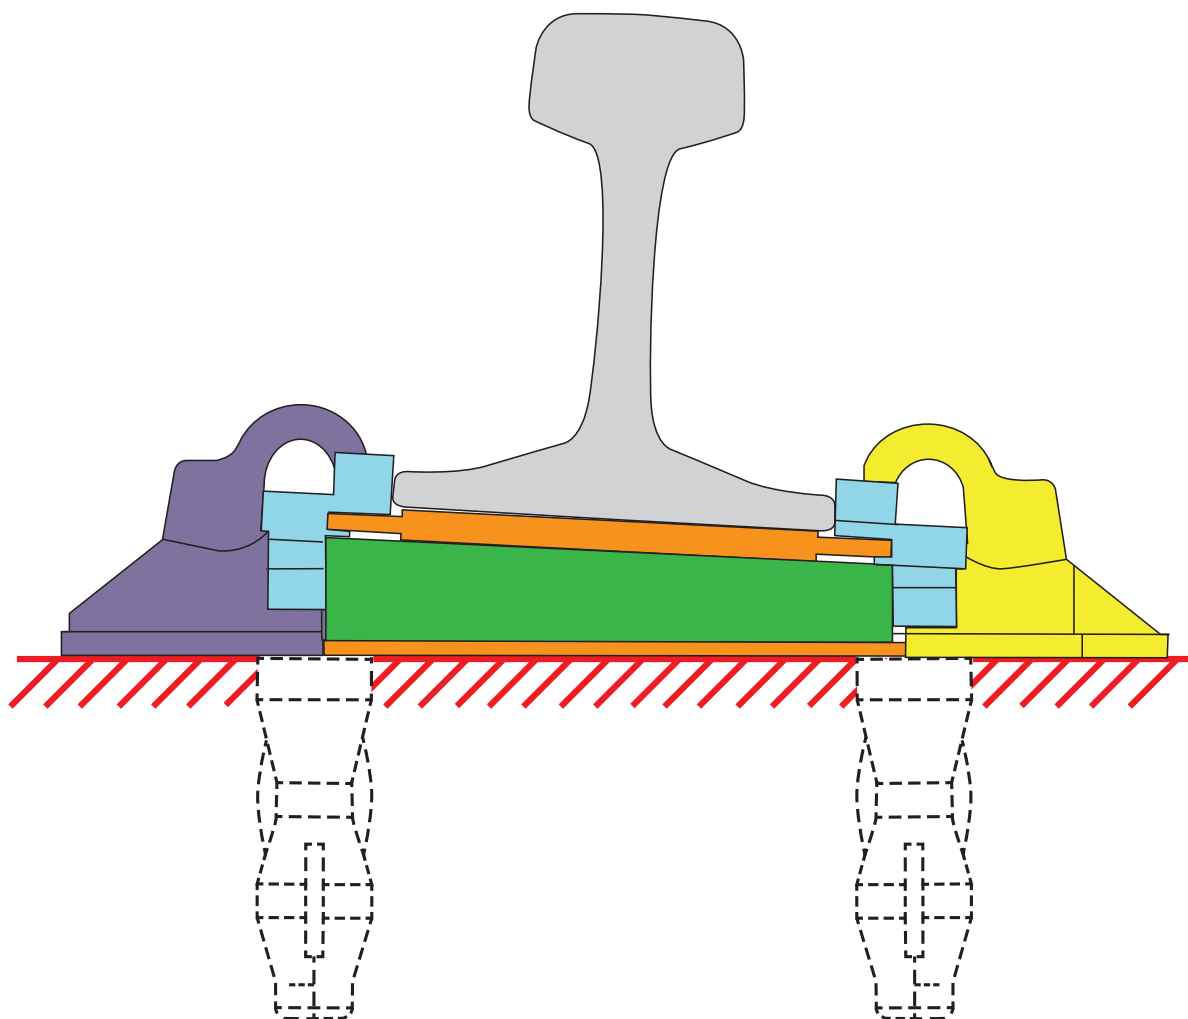
Figure 10: Cross section of a BBRE RT60 layout highlighting the cast iron wedge (green) and elevated shoulder (purple).
