Rail Accident Investigation Branch

# Rail Accident Report

## Freight train derailment at Eastleigh, Hampshire 28 January 2020

Report 02/2021  
March 2021

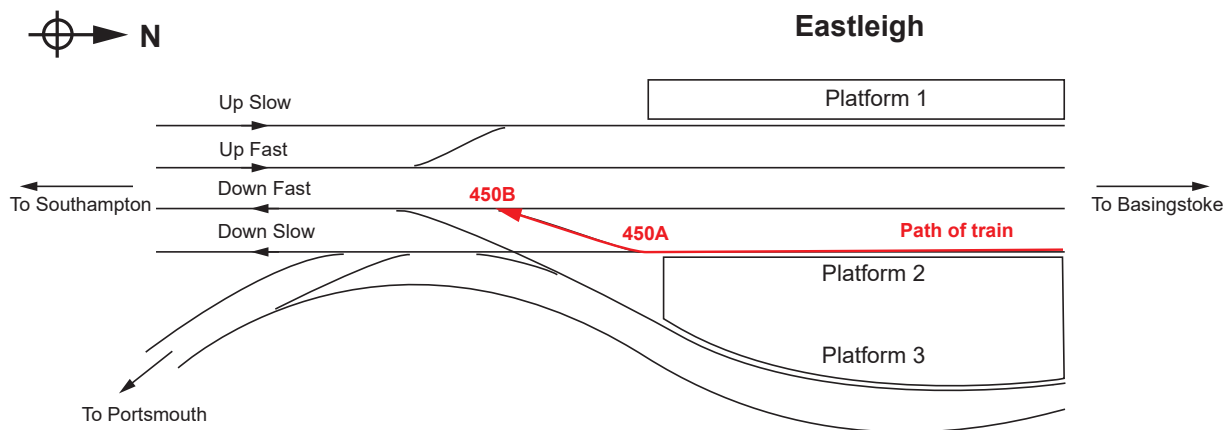
Figure 3: Track layout at Eastleigh station

- 7 The derailment occurred at the south end of Eastleigh station platform 2, as the train traversed 450A points. These form part of a crossover<sup>2</sup> with 450B points. At the time of the accident, both 450A and 450B points were set for trains to travel from the down slow line to the down fast line (figure 3). The maximum permitted speed for trains to pass over the crossover is 15 mph (24 km/h).
- 8 Although the railway is level and generally straight at this location, trains need to negotiate tight radius curves when travelling over the crossover.

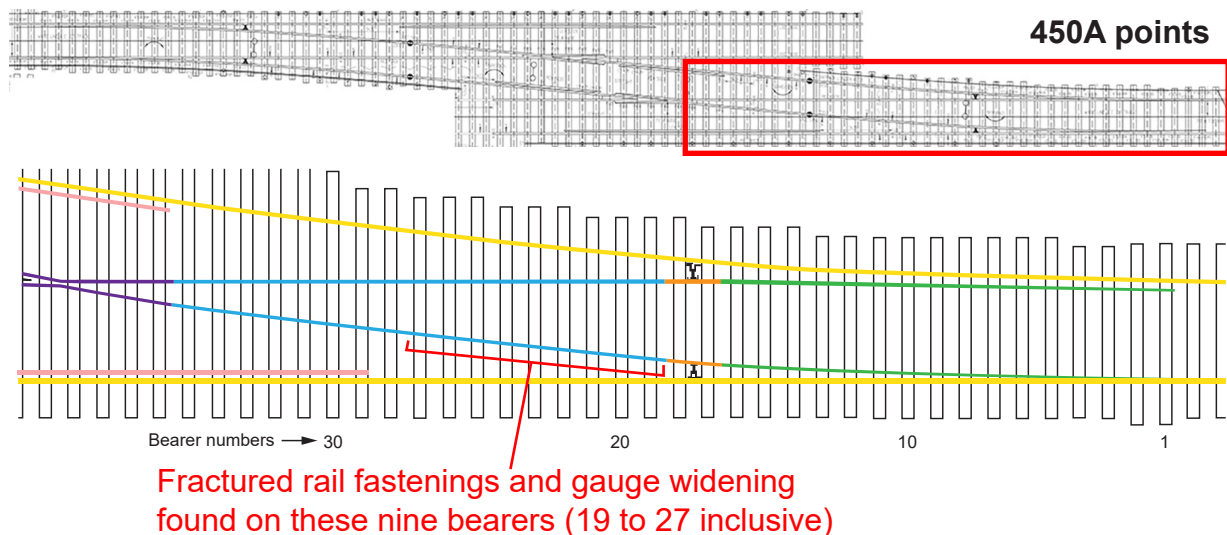
- 25 The train had reached 12 mph (19 km/h) as it arrived at the crossover. The front bogie of the locomotive passed over the switch rails<sup>5</sup> (figure 5) of 450A points without incident. As the locomotive passed over the closure rails,<sup>6</sup> the lateral forces it exerted (see paragraph 78) caused the rails to spread apart, and the failure of additional fastenings (figure 5). This caused all of the locomotive's wheels to drop into the now-widened gap between the rails and to derail. One of the fastenings flew out as it failed and almost struck one of the infrastructure maintenance staff.

Figure 5: Overview of crossover formed by 450A and 450B points and (below) 450A points showing the switch rails (green), stock rails (yellow), check rails (pink), switch heel on baseplates (orange), closure rails on cast iron wedges (blue) and crossing on baseplates (purple).
